MARCH 2018

Brother Genuine Toner Cartridges for the Brother HL-L6300DW versus Ten Third-Party Brands

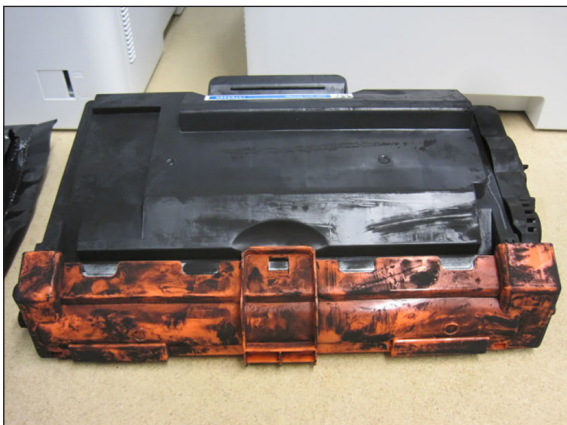
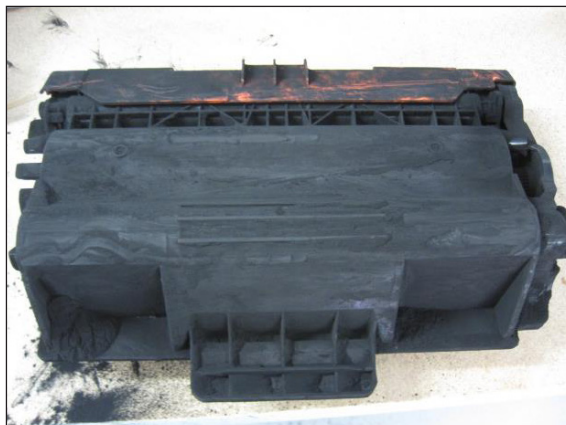
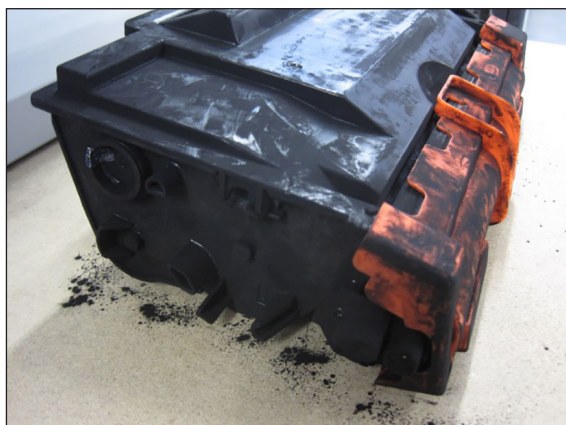
Eight cartridges from Brand G (examples shown above) experienced significant toner leakage right from the start. (Cartridges with this degree of toner leakage are considered out-of-box failures.)

Brand G had eight cartridge failures due to excessive toner leakage, and work surfaces became soiled as the toner was removed from the packaging. In an office environment, the cleanup would cause a delay in getting the machine running again, along with the added inconvenience and cost associated with toner damage to office furnishings or workers' clothes.

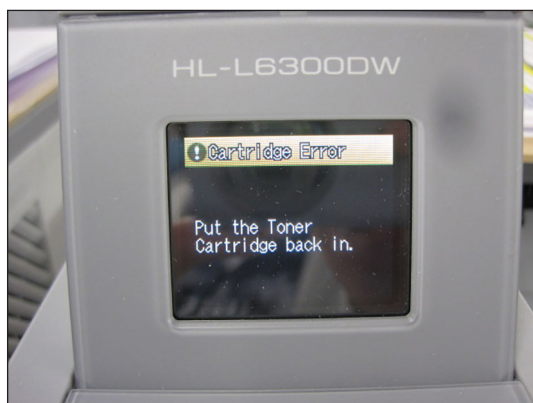
The first Brand K toner cartridge could not be recognized by the device, generating an error code upon installation.

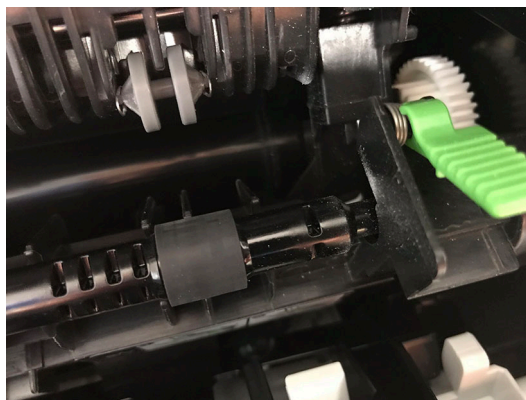
In the machine dedicated to Brother genuine toner (above left), the gear is clean and there is no sign of toner dust on the paper transport or the fuser entrance, above right; similarly, there is no evidence of toner dust at the back of the machine.

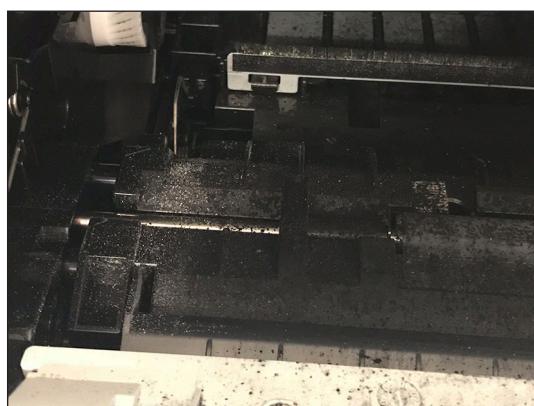
A significant amount of toner dust accumulated in the machine that ran Brand C cartridges (above).

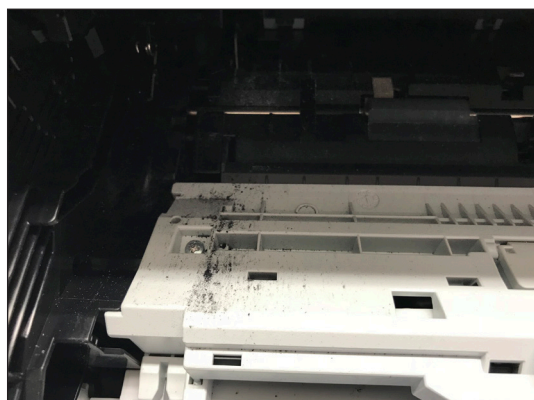
The printer using Brand F cartridges showed significant toner leakage on the manual feed tray, which could contaminate users' hands and pages with toner.

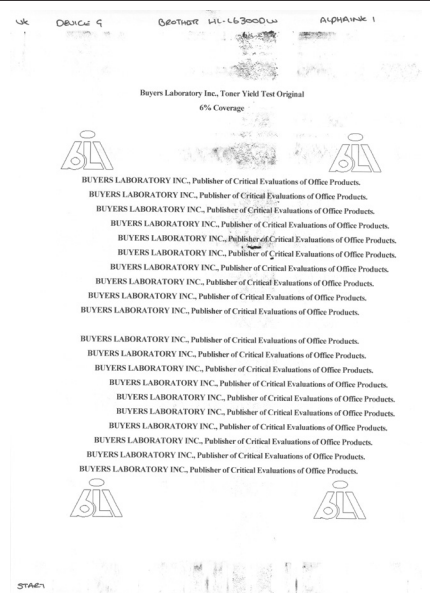
<p>The first page out of Brand G's third cartridge exhibited significant ghosting.</p>
--	--	---

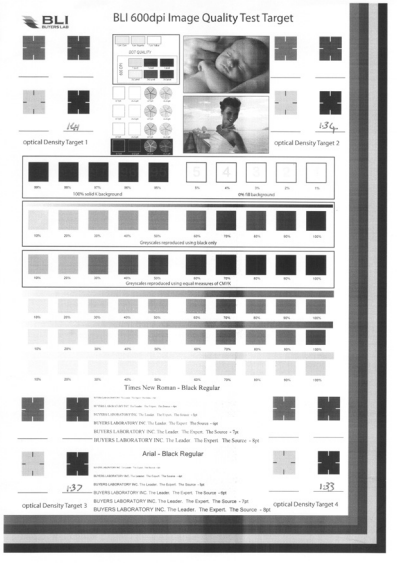
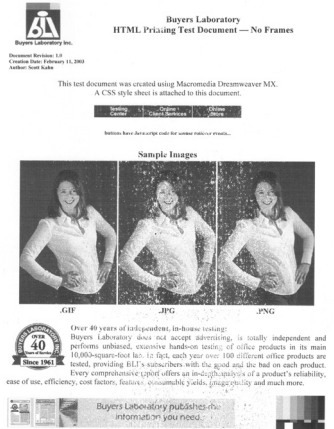
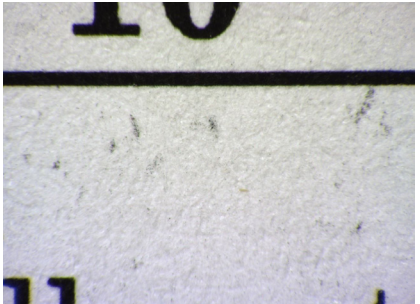
<p>During processing of Brand I's forth cartridge a dark band appeared in the output, clearly seen at the bottom of the page.</p>	<p>Significant flaking was evident on output from Brand K's forth cartridge.</p>	<p>Brand F's fifth cartridge exhibited background overspray, seen here under magnification.</p>

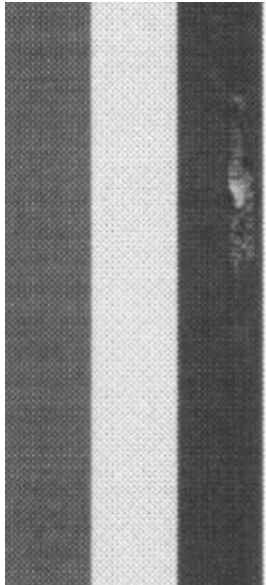
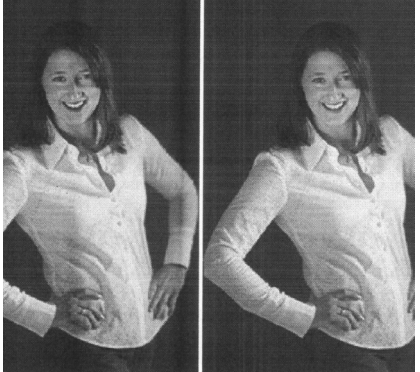
<p>This magnified image shows severe flaking and spots present on Brand B's ninth cartridge.</p>	<p>Although there were no visible signs of drum damage, the latter has caused the white marks that appeared at regular intervals along the right edge of output produced by Brand F's eighth cartridge.</p>	<p>The magnified image above demonstrates the significant amount of streaking that appeared on Brand I's sixth cartridge.</p>

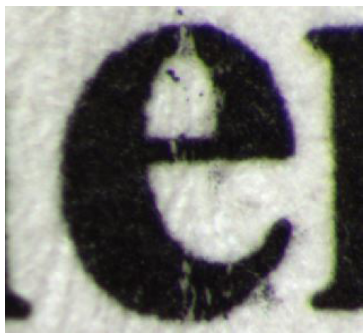
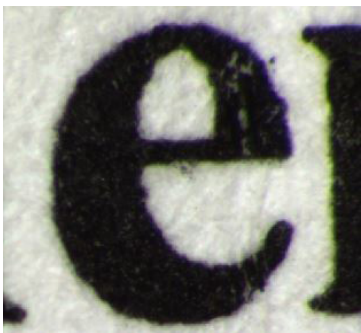
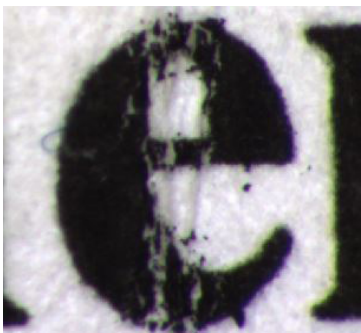
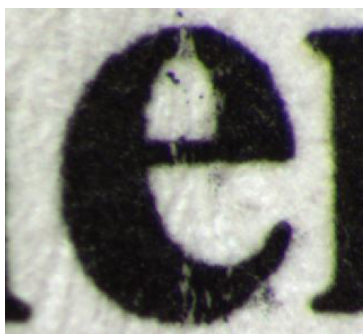
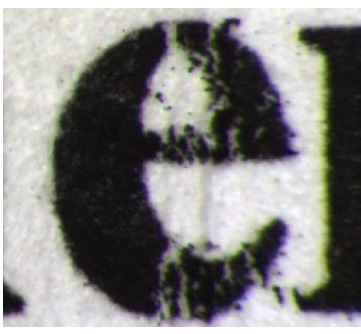
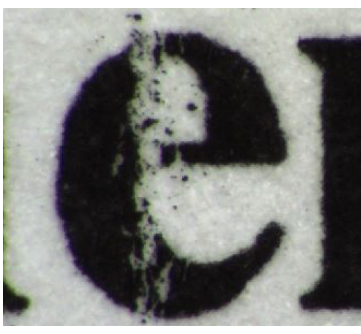
Below are images of the hard crease test results. Samples were taken from cartridge 7 of every brand tested, and images are magnified to show detail.

Minimal	Minimal	Non-excessive

Minimal	Non-excessive	Non-excessive

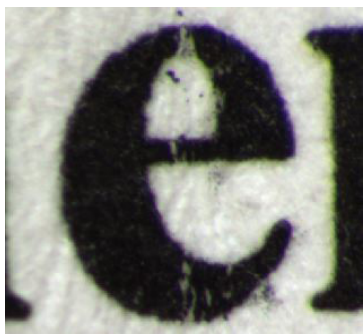
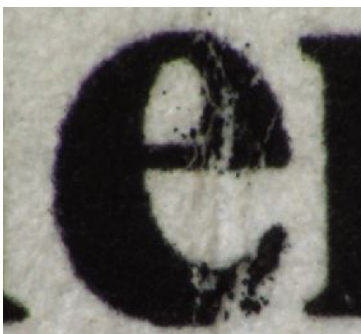
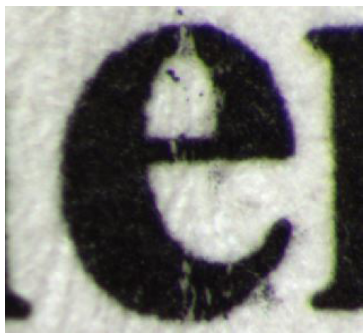
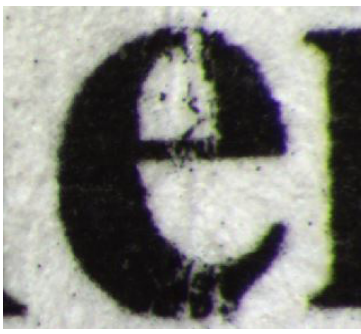
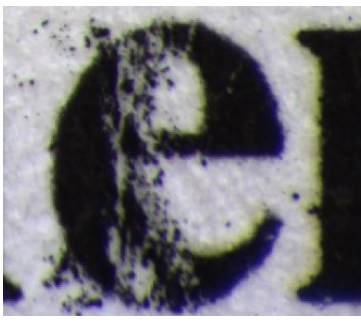
Minimal	Excessive	Non-excessive

Minimal	Non-excessive	Excessive
